BUILDING FAILURES

-CAUSES & CASE STUDIES

M V Rohith Reddy
A Nithin Krishna
B.Tech IIIrd Year
Pondicherry Engineering College
CONTACT:
E-mail: mvrohith94@gmail.com;
nitinkrish01@gmail.com
Phone: 8903307338

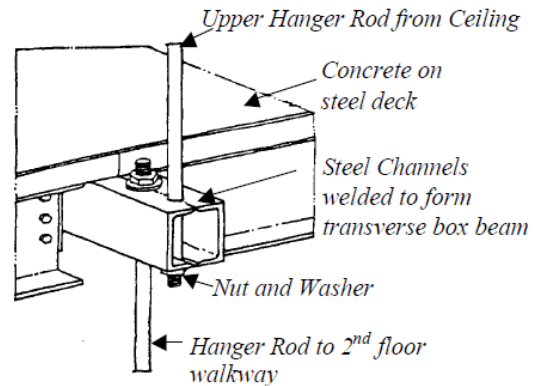
Fig. 5(b): Hyatt Regency Hanger Details As-Built

But the originally designed hanger detail for the two walkways was altered at the time of fabrication as shown in Fig. 5(b).

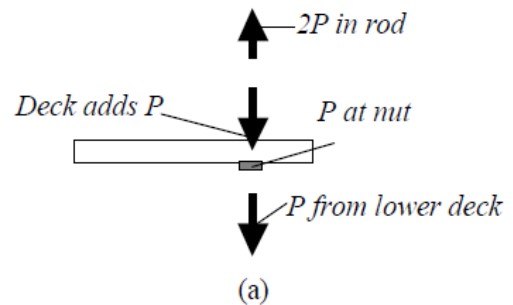
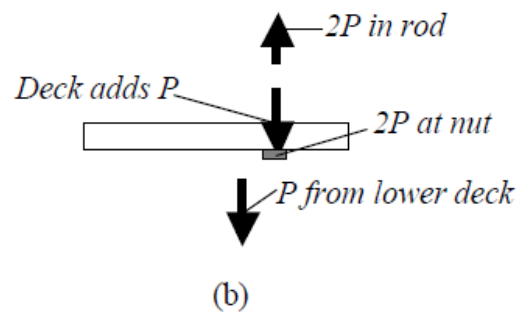
Second floor walkway was suspended from the fourth one as shown. As a result, the connection between the fourth floor cross beam and the hanger supported double the load originally intended as shown in Fig.

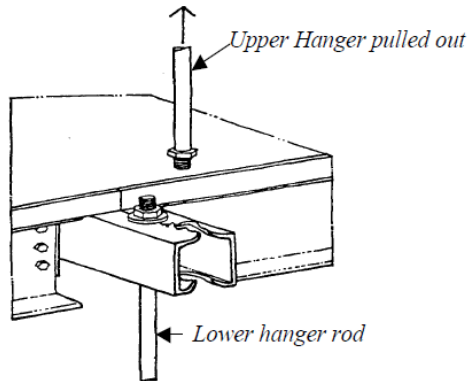
Fig. 7: Pulled-Out Rod at Fourth-Floor Box Beam

This condition was aggravated by the increased load on the nut. The nut pulled through the box beam as shown in Fig.

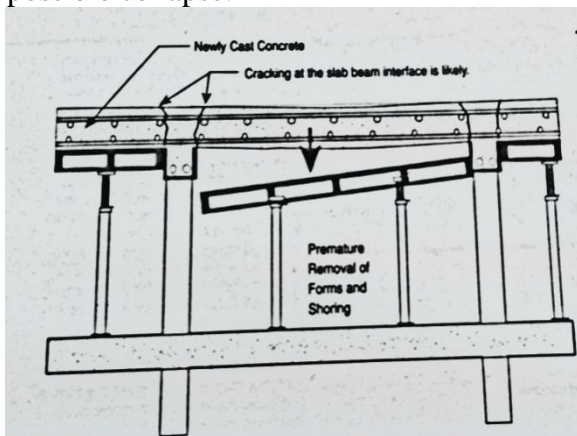
Skyline Plaza, Virginia, USA

- During construction the forms supporting the concrete columns on the 22nd floor were prematurely removed. The cement had not set fully by then. As a result the columns couldn't bear the weight of the 24th floor and failed.
- The failure put an increased amount of pressure on the rest of the columns on the 23rd floor until the entire floor buckled and slammed down on the floor below.
- The building had not been engineered to withstand such a huge increased load, and the tremendous weight proved catastrophic. Each floor gradually succumbed and plummeted onto the story below in a devastating ripple effect.

Lesson Learnt: Though design may be sound but so should be the execution per design and observing right construction which practice, in this case has been found wanting. Inspection & testing coupled with regular supervision are not mere formalities but activities that can make or mar a project; or shall we say, make or break a building!

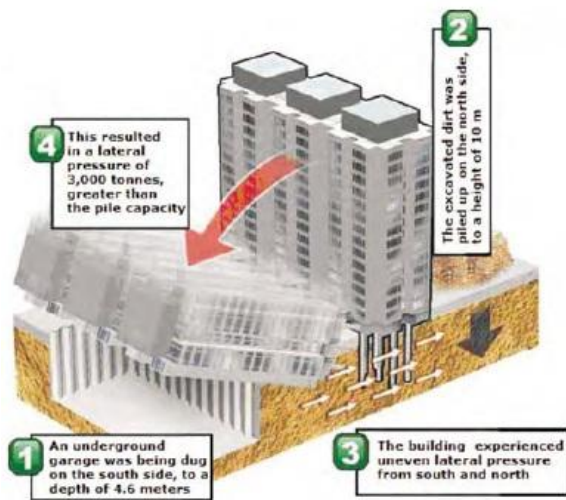
The cause of the building collapse in Shanghai was due to a pressure difference on two sides of the structure. The collapse was caused by earth, excavated along the building on one side with a depth of 4.6 m, for an underground car park, and piled up to depths of up to 10 m on the other side of the structure (see Fig. 2). The weight of overburden earth created a pressure differential, which led to a shift in the soil structure, eventually weakening the foundations and causing them to fail. This situation might have been aggravated by several days of heavy rain leading up to the collapse, but investigators did not site this as a crucial factor.

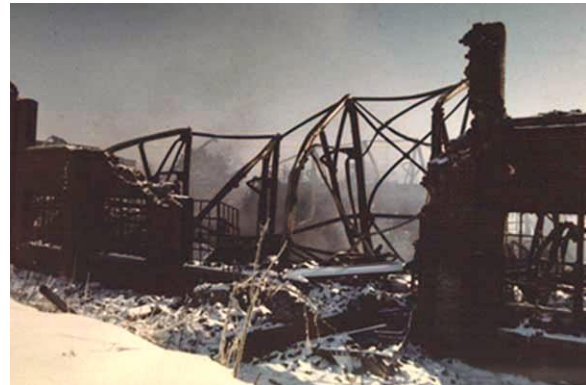
foundation would repel any such assault with ease, as it indeed did. The impact of aircraft on the upper stories had only a local effect, and did not impair the integrity of the buildings, which remained solid. The fires caused weakening of the steel, and some of the floors suddenly received a load for which they were not designed. Each tower contains about 1,00,000 tons of steel and concrete. Assuming the aircraft damaged the north tower structure at about 80% of the total height, then roughly about 20,000 tons would be borne by the structure that survived. The reduced structural capacity was the first ingredient in the failure. The second was the heating effect brought on by the burning jet fuel. As temperatures approach 1500 F, structural steel loses its ability to support weight and begins to deform which is known as thermal creep. Figure 2 shows a view of typical steel beams and columns after a fire.

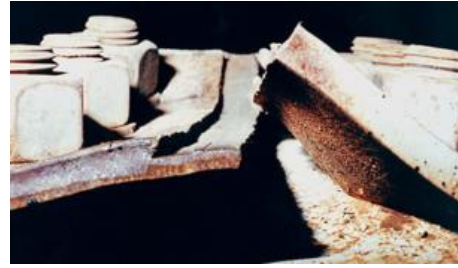
1. the building had drain deficiencies
2. choice of materials for bolts("Steel codes[the ASTM A490] suggests not to use bolts under variable loads,")

3. lack of redundancy under partial failure.
