BUILDING FAILURES

-CAUSES & CASE STUDIES

M V Rohith Reddy
A Nithin Krishna
B.Tech IIIrd Year
Pondicherry Engineering College
CONTACT:
E-mail: mvrohith94@gmail.com;
nitinkrish01@gmail.com
Phone: 8903307338

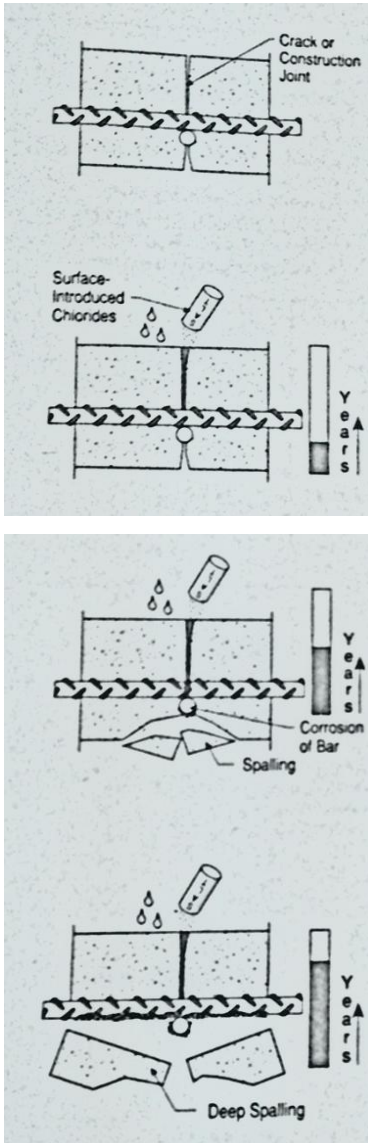
SULPHATE ATTACK

- ✓ Main causes –
 - i. Sulphate attack
 - ii. carbonation

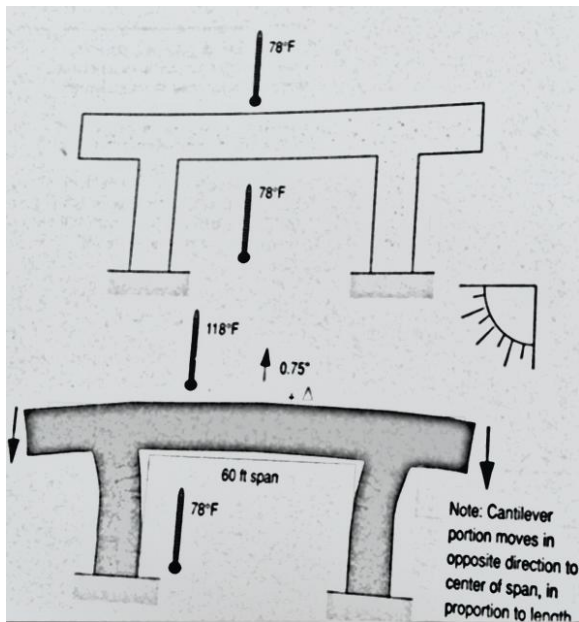
UNEVEN THERMAL LOADS:-

Temperature gradients exist in many structures. The temperature of the deck slab exposed to direct sunlight may reach 48°C, while the underside of the deck slab may be only 26°C. A 22°C difference known as **diurnal solar heating**. This causes the top surface to have a tendency to expand more than the bottom surface. This results in an upward movement during heating and downward movement during cooling

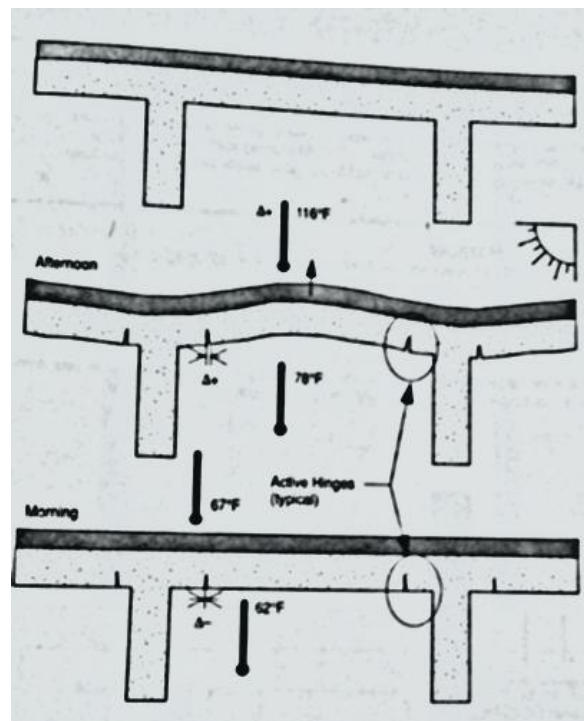
Diurnal solar heating affects structures differently depending on the configuration. Simple span structures deflect up and down and are free to rotate at end supports. Continuous spans behave differently because they are not free to rotate at end supports. If enough thermal gradient exists along with insufficient tensile capacity in the bottom of the member, a hinge may form. Hinges form randomly in newly formed cracks or near construction joints of the columns. Hinges open and close with daily temperature changes.

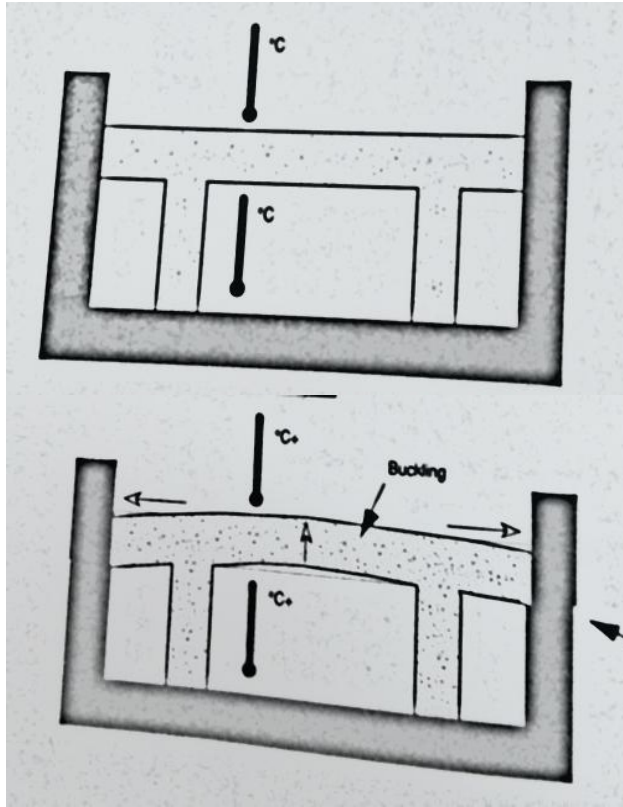
Restrain to volume changes:-

If a structural member is free to deform as a result of changes in temperature, moisture or loads, there is no build-up of internal stress. If the structure is restrained, stress build-up occurs and can be very significant. The stress may result in tension cracks, shear cracks, and buckling.

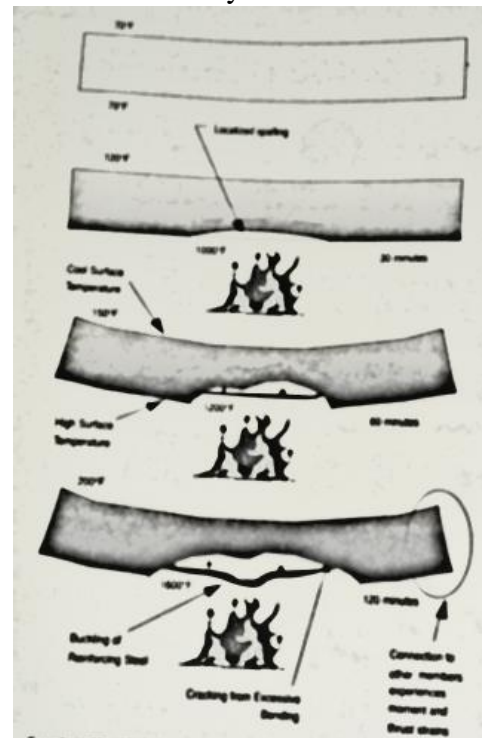
- Uneven volume changes in affected members, resulted in **DISTORTION, BUCKLING & CRACKING**.
- Spalling of rapidly expanding concrete surfaces from extreme heat near the source of fire. Some aggregates expand in bursts, spalling the adjacent matrix. Moisture rapidly changes to steam, causing localized bursting of small pieces of concrete.
- The cement mortar converts to quick lime at temperatures of 400°C , thereby causing disintegration of the concrete.
- Reinforcing steel loses tensile capacity as temperature rises.
- Once the reinforcing steel is exposed to the spalling action, steel expands more rapidly than the surrounding concrete, causing buckling and loss of bond to adjacent concrete where the reinforcement is fully encased.
